International Symposium
Qualification of dynamic analyses of dams and their equipments
and of probabilistic assessment seismic hazard in Europe
31th August – 2nd September 2016 – Saint-Malo

Y. Nakamura & K. Narita
Aichi Institute of Technology,
Toyota-Shi, Aichi, Japan

Session 2: Performance of AFRD & ACRD

Evaluation of Earthquake Resistance on Asphalt Facing

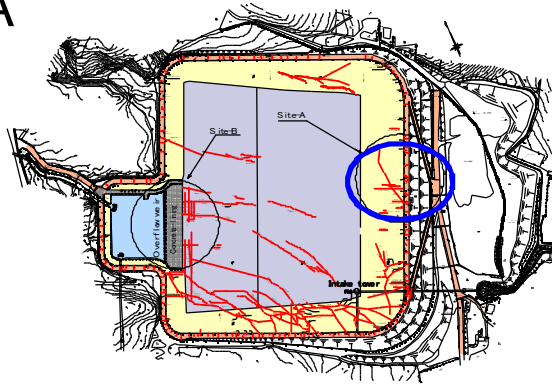
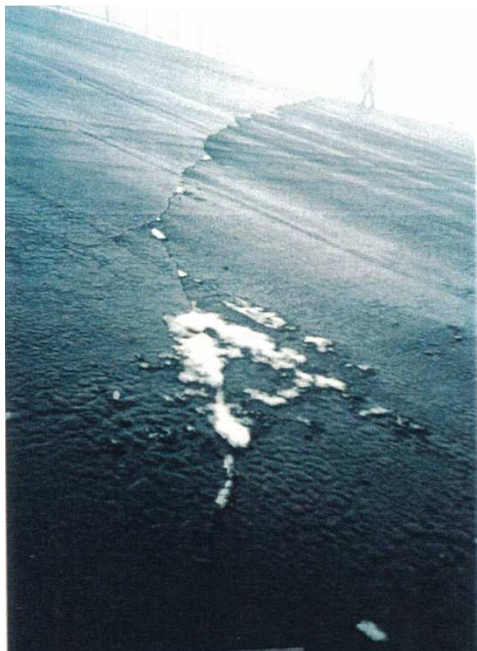
Site-A

Cracks of Asphalt-facing discovered

just after the earthquake (1996/3/8)

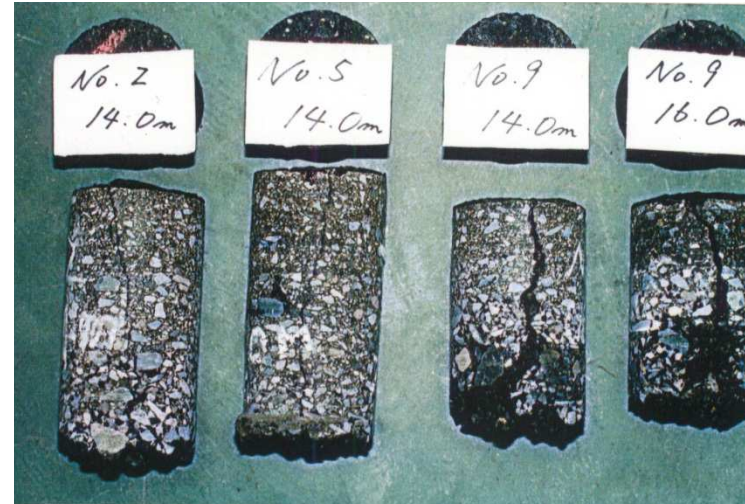
Cracks in Asphalt Facing with boring core

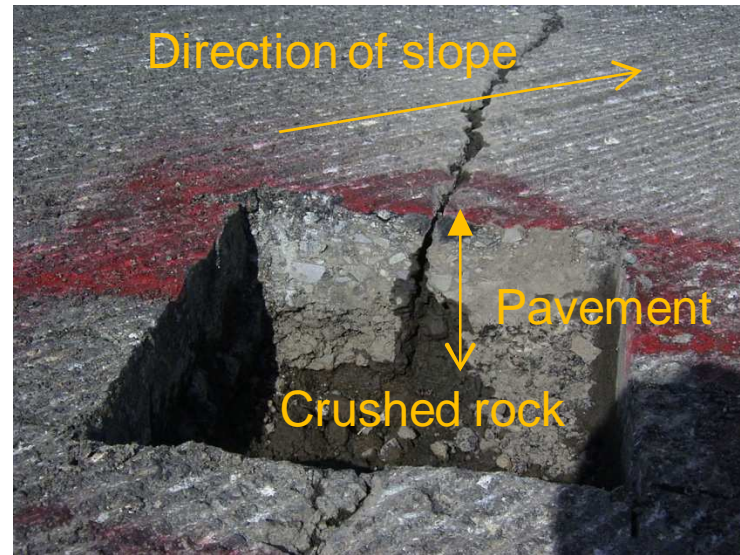
Cracks in Asphalt Facing with opencut on repair work

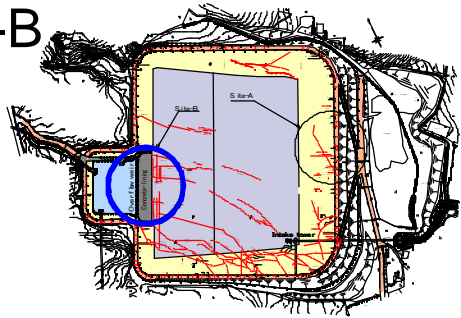
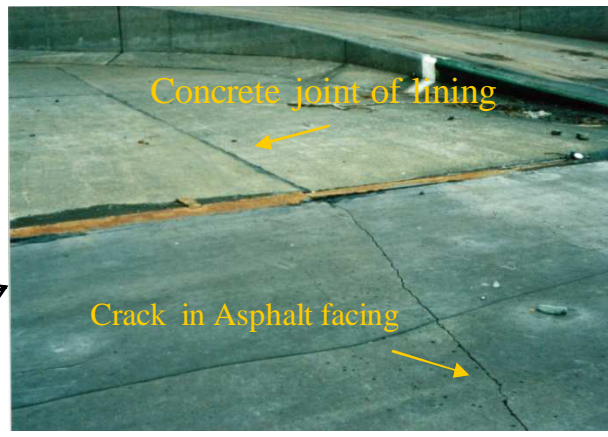
Site-B

Cracking due to concrete joint of lining

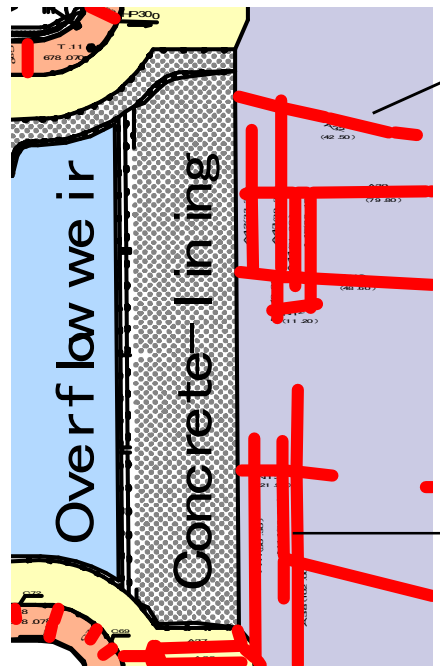
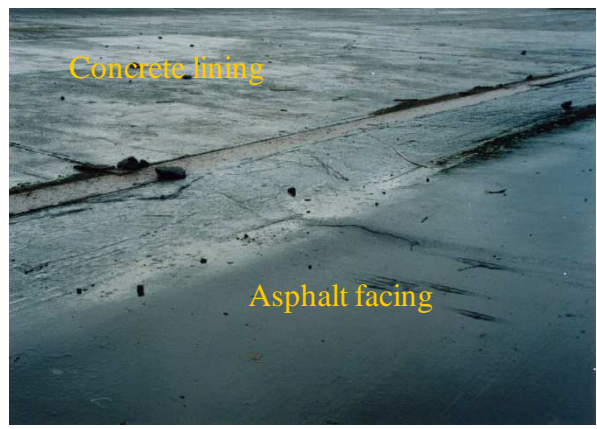
Cracking due to difference in rigidities

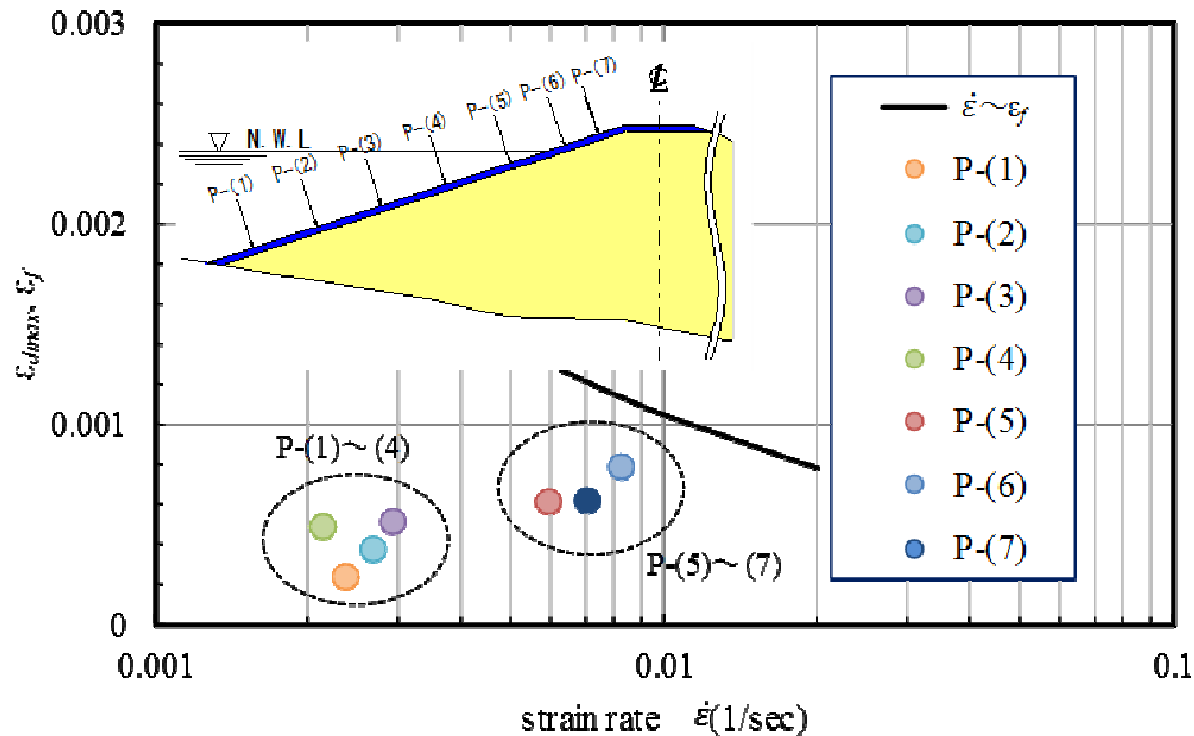
Failure Evaluation along slope ($\alpha_B = 85\text{gal}$, St60/80)

- In this type of safety evaluation, the condition $F_s < 1.0$ should be appropriate to recognize its critical state of the facing zone.
- Taking reduction in flexibility due to aging effects of more than 25years into account
