International Symposium
Qualification of dynamic analyses of dams and their equipments
and of probabilistic assessment seismic hazard in Europe
31th August – 2nd September 2016 – Saint-Malo

Y. Nakamura & K. Narita
Aichi Institute of Technology,
Toyota-Shi, Aichi, Japan

Session 2: Performance of AFRD & ACRD

Evaluation of Earthquake Resistance on Asphalt Facing

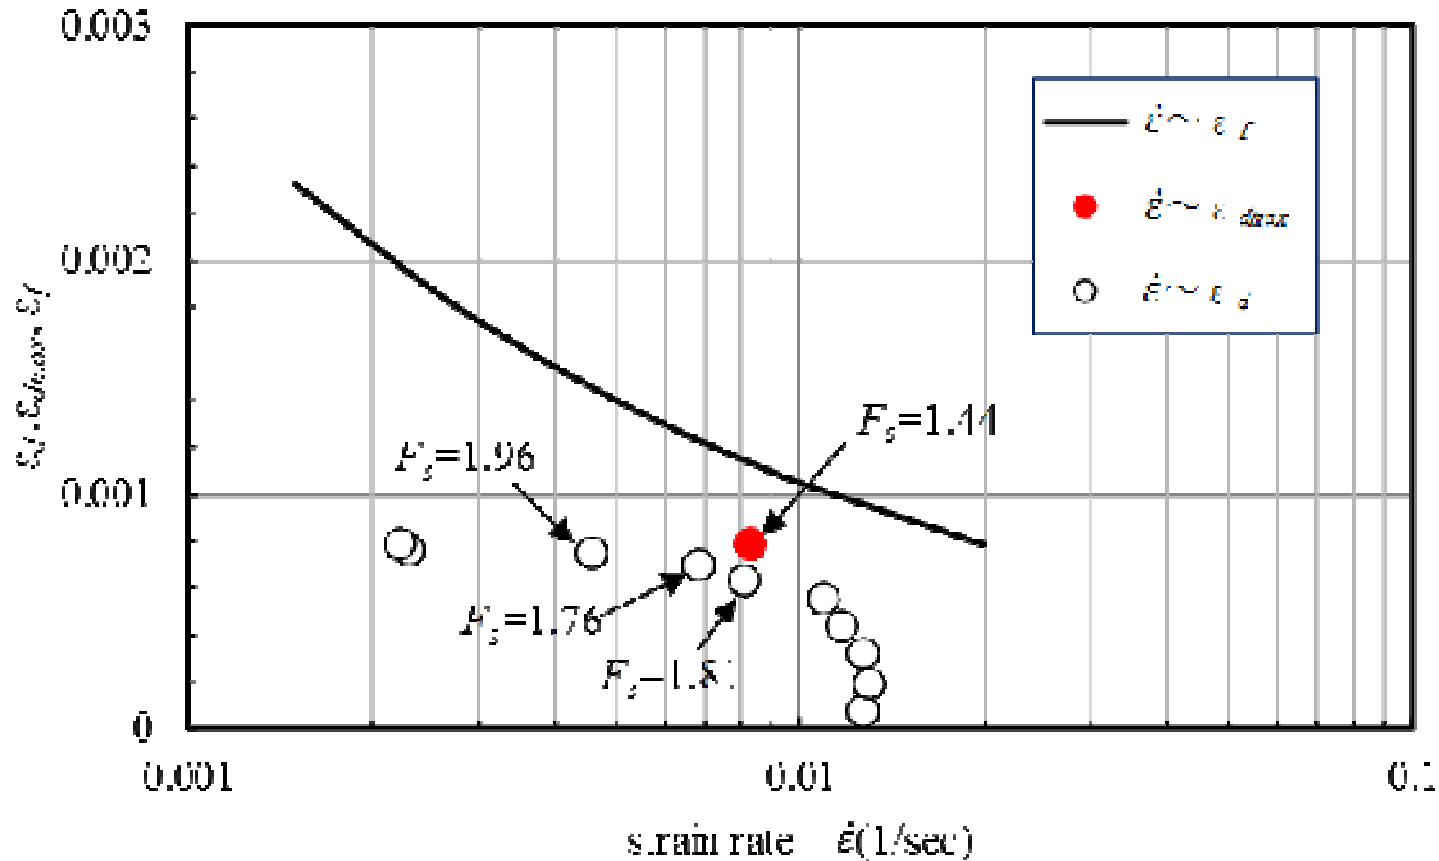
Dynamic Strain and Failure Strain in P-(6)

○ : the values of ϵ_d and $\dot{\epsilon}$ in a time interval $\Delta t = 0.01$ sec

● : the value of $\dot{\epsilon}$ is estimated on average as a quarter of period of wave at this peak can be read as $\Delta t = 0.0095$ sec.

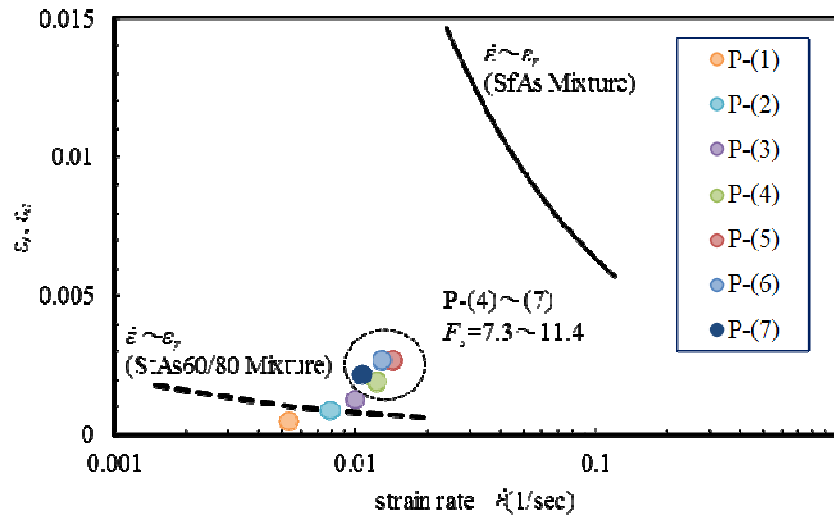
Safety Evaluation by Strain at Failure ($\alpha_B=200gal$, SfAs)

- ◆ It is recognized that the impervious zone composed of the improved asphalt mixture SfAs gives sufficiently safe side value in damage evaluation for the L1-level earthquake. In the L2-level earthquake, though some cracking failures are anticipated to occur near the dam crest, such damages of the impervious zone as involving severe leakage of the reservoir water are not probable because much less probability of failure is proved in the analysis in the lower part of the dam below the high water level.
